NASA
Spaceport Engineering and Technology Directorate
Labs and Testbeds Division
Kennedy Space Center, Florida

KSC-MSL-0527-2001

SUBJECT: Failure Analysis of a Windlock Jackscrew

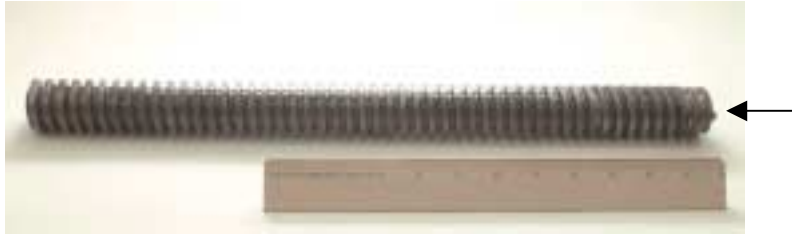
Figure 1

- 3.1 The failed jackscrew was photographed as-received (Figure 1). Figure 2 is a higher magnification view of the fracture surface showing the direction of the failure.
- 3.2 The fracture surface was cleaned in preparation for analysis by scanning electron microscope (SEM). SEM analysis determined that the fracture surface displayed primarily ductile features with localized regions of transgranular cleavage (Figures 3 and 4). The directionality of the dimples formed by microvoid coalescence (MVC) indicated that the jackscrew failed in torsional overload while under tensile stress. A laboratory-induced overload exemplar displayed equiaxed dimples formed by MVC, indicative of ductile tensile overload (Figure 5).

Failed jackscrew, as-received. Arrow indicates fracture surface.

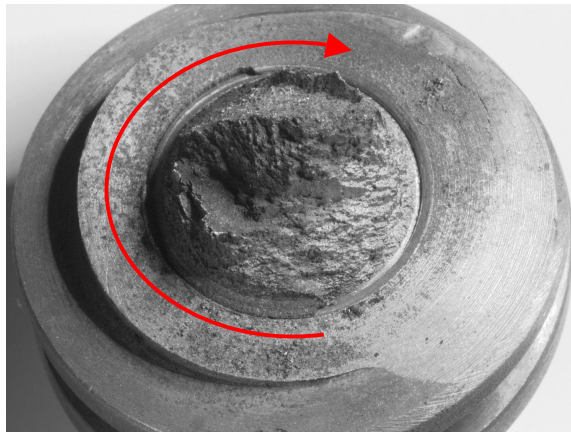
Figure 2

Jackscrew fracture surface. Arrow indicates direction of fracture propagation.
Magnification: 2X

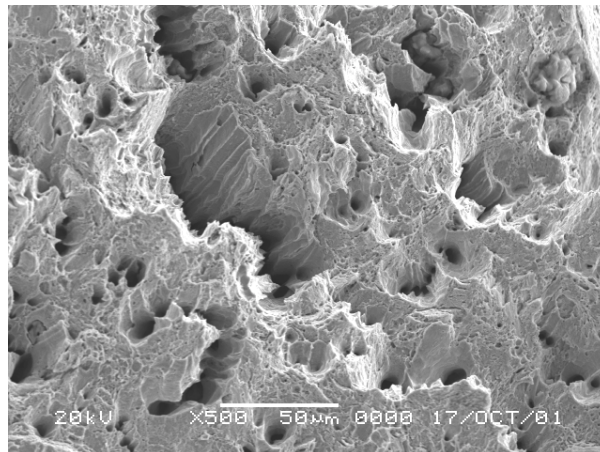
Figure 3

SEM micrograph showing dimples formed by MVC. Magnification: 500X

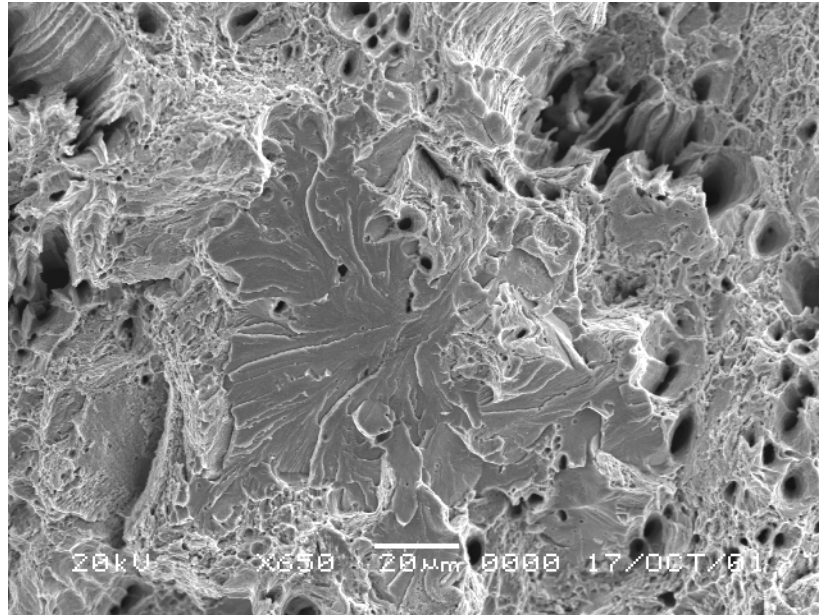
Figure 4

SEM micrograph showing a localized region of transgranular cleavage, surrounded by dimples formed by MVC. Magnification: 650X

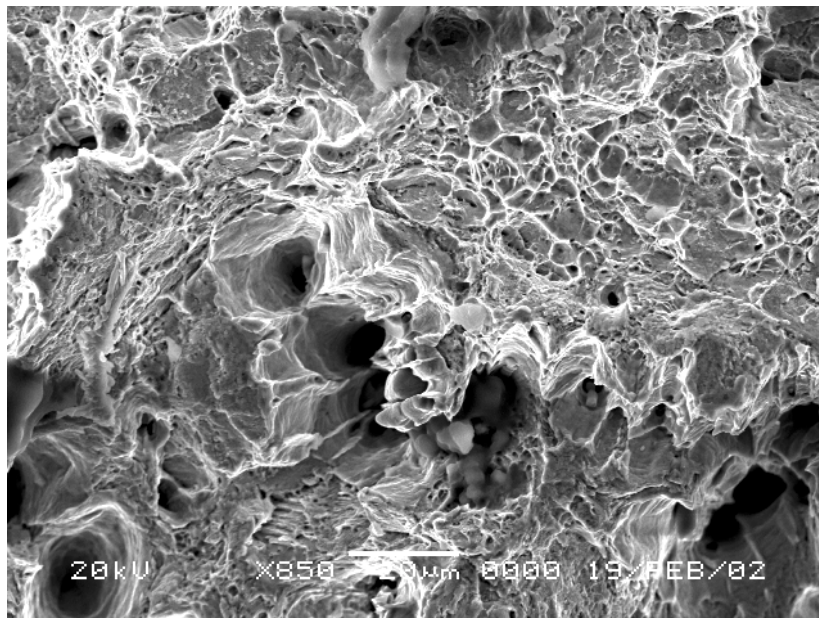
Figure 5

SEM micrograph of laboratory-induced overload exemplar, showing equiaxed dimples formed by MVC. Magnification: 850X

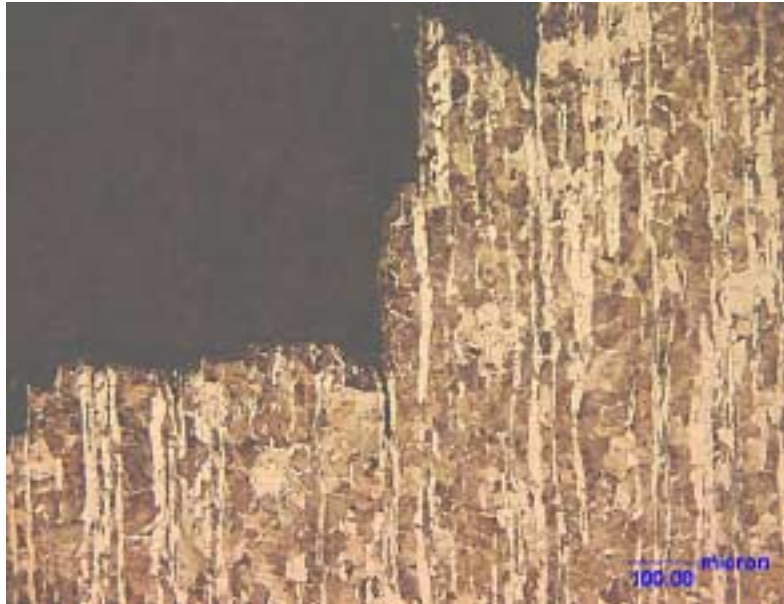
Figure 6

- 3.3 The fracture surface was sectioned longitudinally and prepared for metallographic analysis. No crack branching was observed, further indicating that the jackscrew failed in a ductile manner. The microstructure consisted of banded ferrite and pearlite with manganese sulfide stringers (Figures 6 and 7).
- 3.4 Converted microhardness measurements taken on the longitudinal cross section averaged 30 Rockwell C scale, corresponding to an approximate tensile strength of 136 ksi.
- 3.5 A section of the jackscrew was submitted to YA-F4-C for chemical analysis. Analysis by inductively coupled argon plasma and combustion methods determined that the jackscrew was composed of AISI 1000 series carbon steel.

Micrograph showing a longitudinal cross section of the fracture surface (top). The microstructure is banded ferrite (light) and pearlite (dark). Etchant: 2% nital
Magnification: 100X

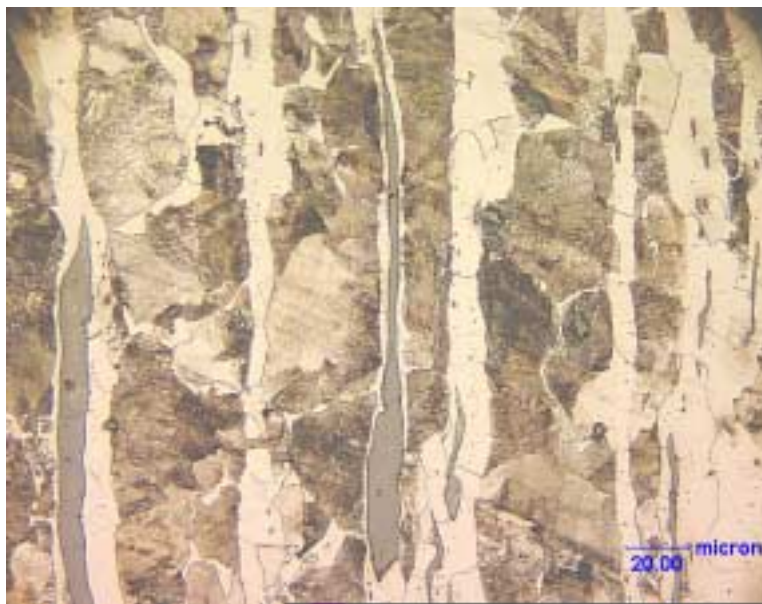
Figure 7

Micrograph showing the bulk microstructure of the longitudinal cross section. The gray feature in the center of the image is a manganese sulfide stringer. Etchant: 2% nital. Magnification: 500X
